Status and ENERGY Audit

KS School of Engineering and Management

January 2024

e-Xcel Energy Bangalore

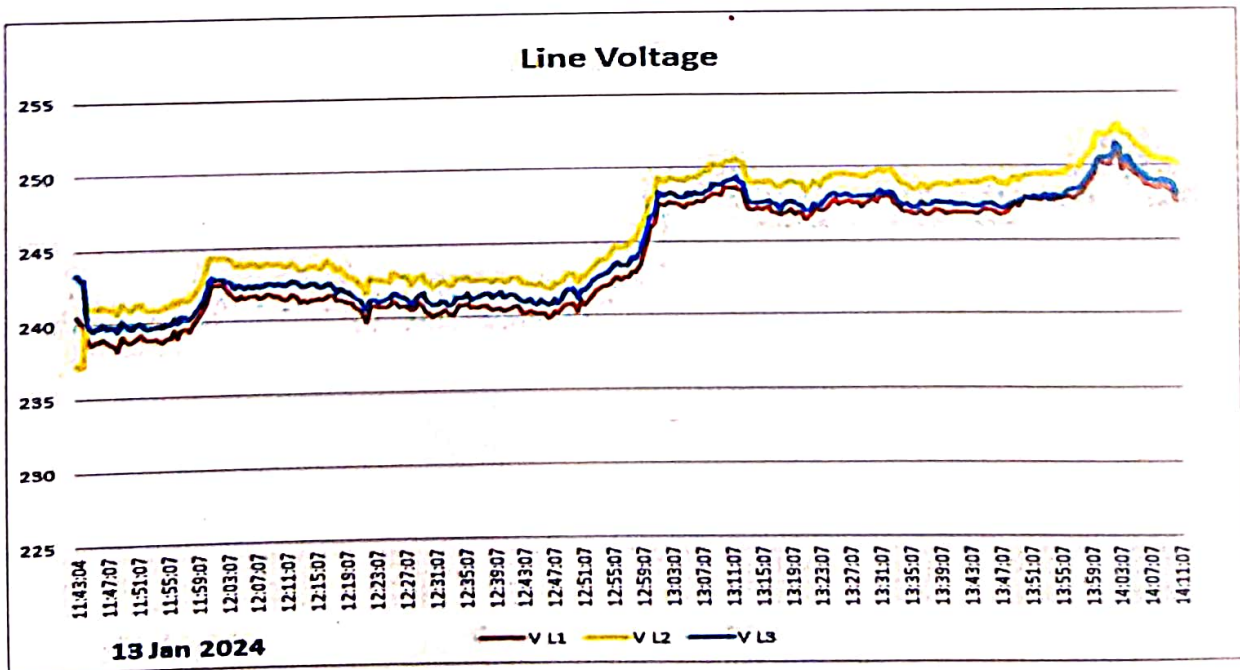
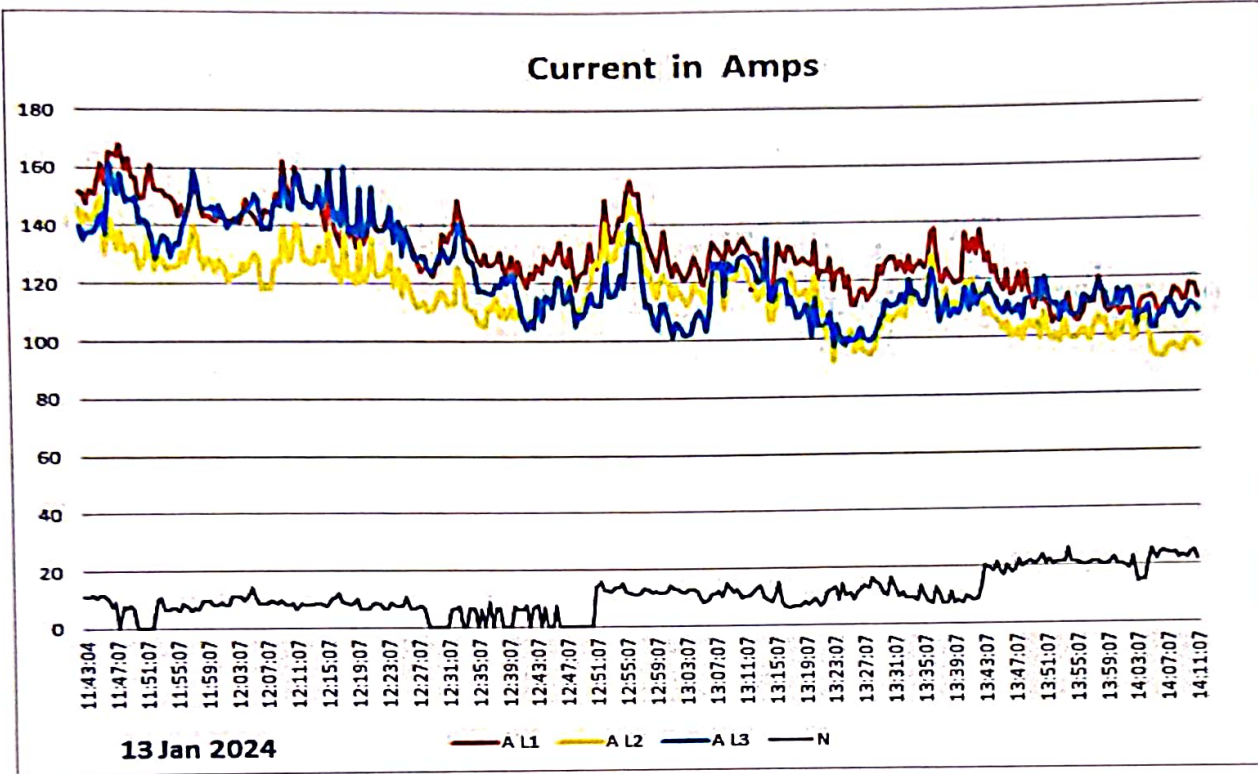
Table 2.1

- 1) Line voltages is varying between 240V to 250V which is on the higher side, leading to a small amount of energy loss.
- 2) Neutral current is present and is varying between 10A to 20A, this is partially due to unbalance in the loads and partially on account of Harmonic currents.
- 3) The harmonic currents are distorting the load current waveform as shown above
- 4) Presence of harmonic currents is because of 6-pulse (H5 & H7) and 12-pulse (H11 & H13) rectifiers in the UPS systems being used without any filtering devices.

- 1) The “Tap” setting in the transformer to be adjusted to get an output voltage in the range of 230V to 235V, this will not only save energy but will also protect electrical/Electronic instruments using mains supply.
- 2) Load Balancing exercise to be carried out to shift some single phase loads from R phase to Y & B phases.
- 3) Mitigation of harmonics is necessary to smoothen the current waveform particularly the 5th, 7th 11th and 13th Order harmonic currents.

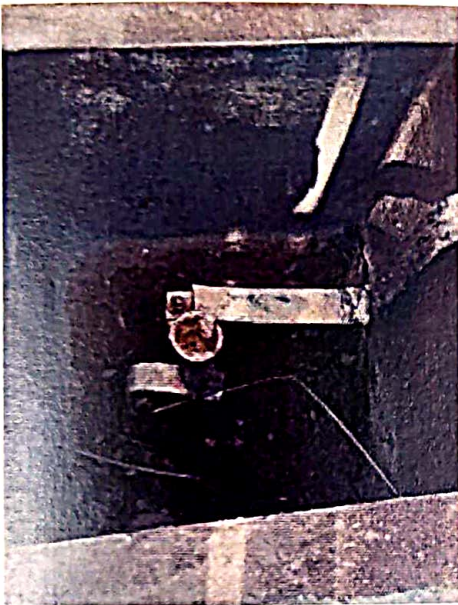
DG Neutral EP

SI No	Location Description	Resistance Ω	Remarks
DG Area			
01	Earth Pit-01 250kVA DG Neutral	0.62	Bolts rusted
Transformer Yard			
04	Earth Pit-02 Trafo Neutral - 1	0.27	Passed
05	Earth Pit-03 Trafo Neutral - 2	0.30	Passed

- The earth pits for DG1 (250kVA) have failed in their tests and hence have to be re-conditioned.
 - The earth pits for DG2 (125kVA) are not traceable, hence new pits have to be provided.

- 1) Please mark the borders of the pit with Yellow/Green paint and the lid/Cover with yellow and black stripes.
- 2) The resistance value with the test and Due dates to be marked on the lids/Covers

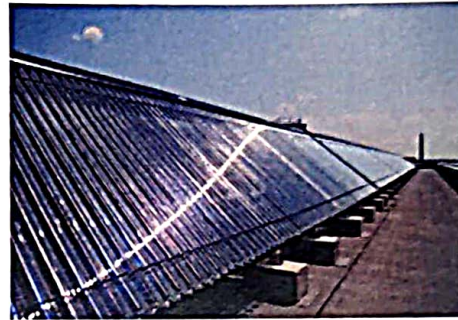
- Use the solar Water heater water in a mixing tank which acts as the feed water to the heap pumps with suitable set point so that the Heat pumps will operate only when the temperatures are low from the solar tank.

Recurring annual cost savings	: Rs. 1,80,500 (32,400 units saved)
Capital Investment	: Rs. 21,70,500
Payback Period	: 12 months
Savings measurement	: Direct

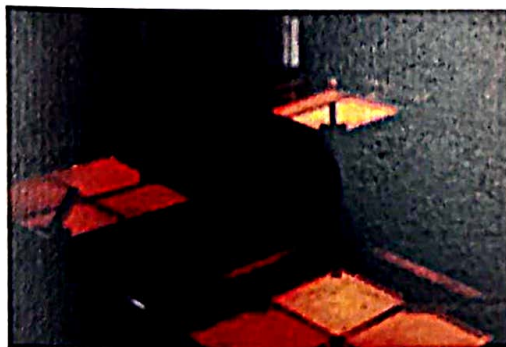
PROPOSED ENERGY-EFFICIENT STOVES

- Replace conventional type LPG gas stove and burners with patented energy-efficient radiant heating technology using the same LPG. The 24 gas stoves are recommended for replacement with the new radiant heating stoves.
- The proposed heating system thermal efficiency is in the range of 65 - 68 % which is equivalent to about 30 % savings in LPG
- Proposed heating system is indirect heating, so it improves even heat distribution over the vessel/pan and there is no carbon soot formation on the vessels
- This scheme is successfully implemented in several Hotels and staff canteens across India including Taj and ITC group of hotels.
